Inspection Report

Minerals Regulatory Program

Mine Name: DKG Quarry

Permit number: M/015/041

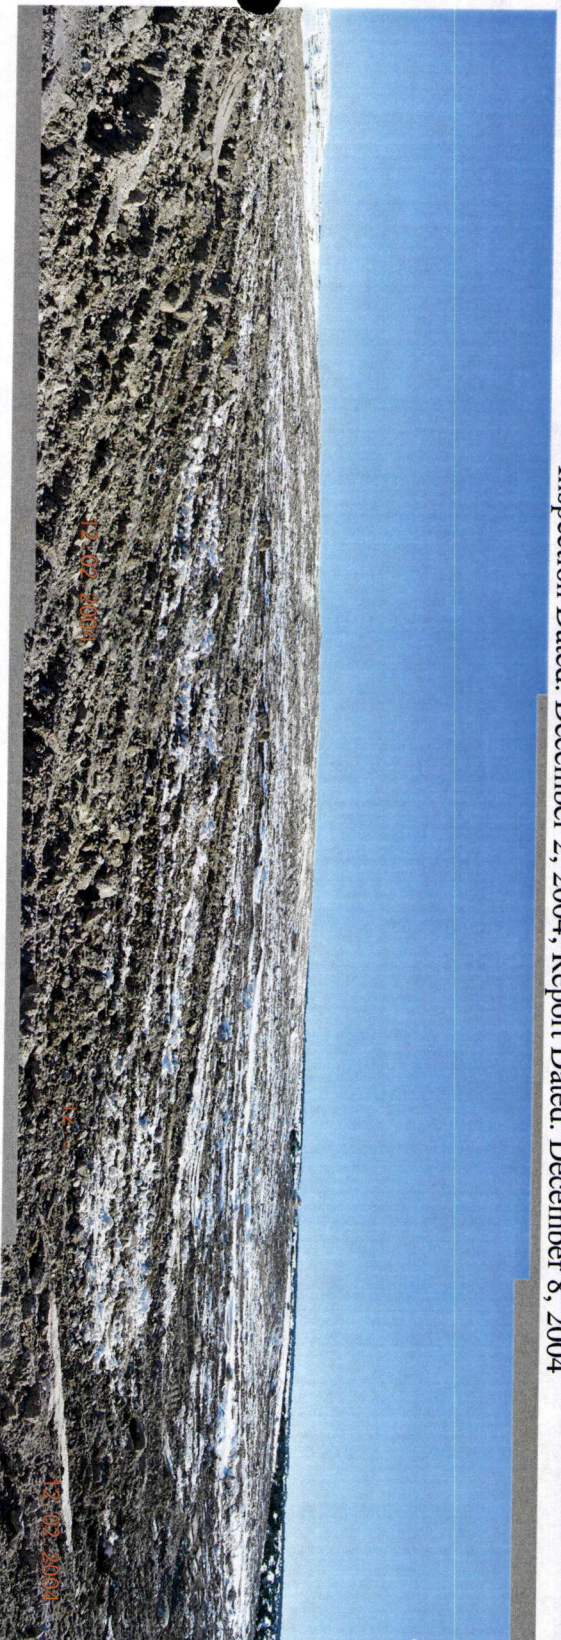
I am pleased with the grading that has been done (Photo 1). The site resembles adjacent undisturbed areas, and it is very rough. There is a small swale in the southwest part of the area that should collect runoff from most of the reclaimed area, but because the site is so rough, I do not anticipate much runoff.

Photo 1. Panorama of the main part of the regraded area. Note the roughness and the depression in the lower right.

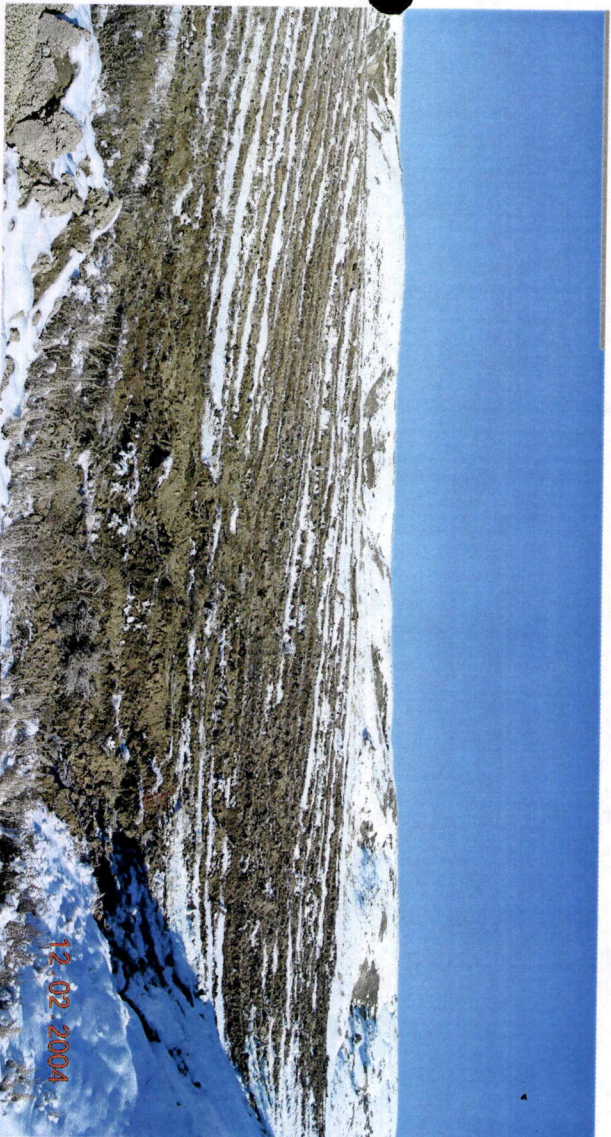
There is an area that was reclaimed a few years ago where revegetation has not been very successful. This area was re-ripped, but the rips were nearly perpendicular to the contour in part of the area (Photo 2). I asked the operator to redo this portion with the rips running parallel to the contour. As I was leaving, the dozer was getting to the site to do this work.

Photo 2. This is an area that was previously graded and seeded. The operator has re-ripped the area, and I asked that the area on the left of this photo be ripped parallel to the contour.

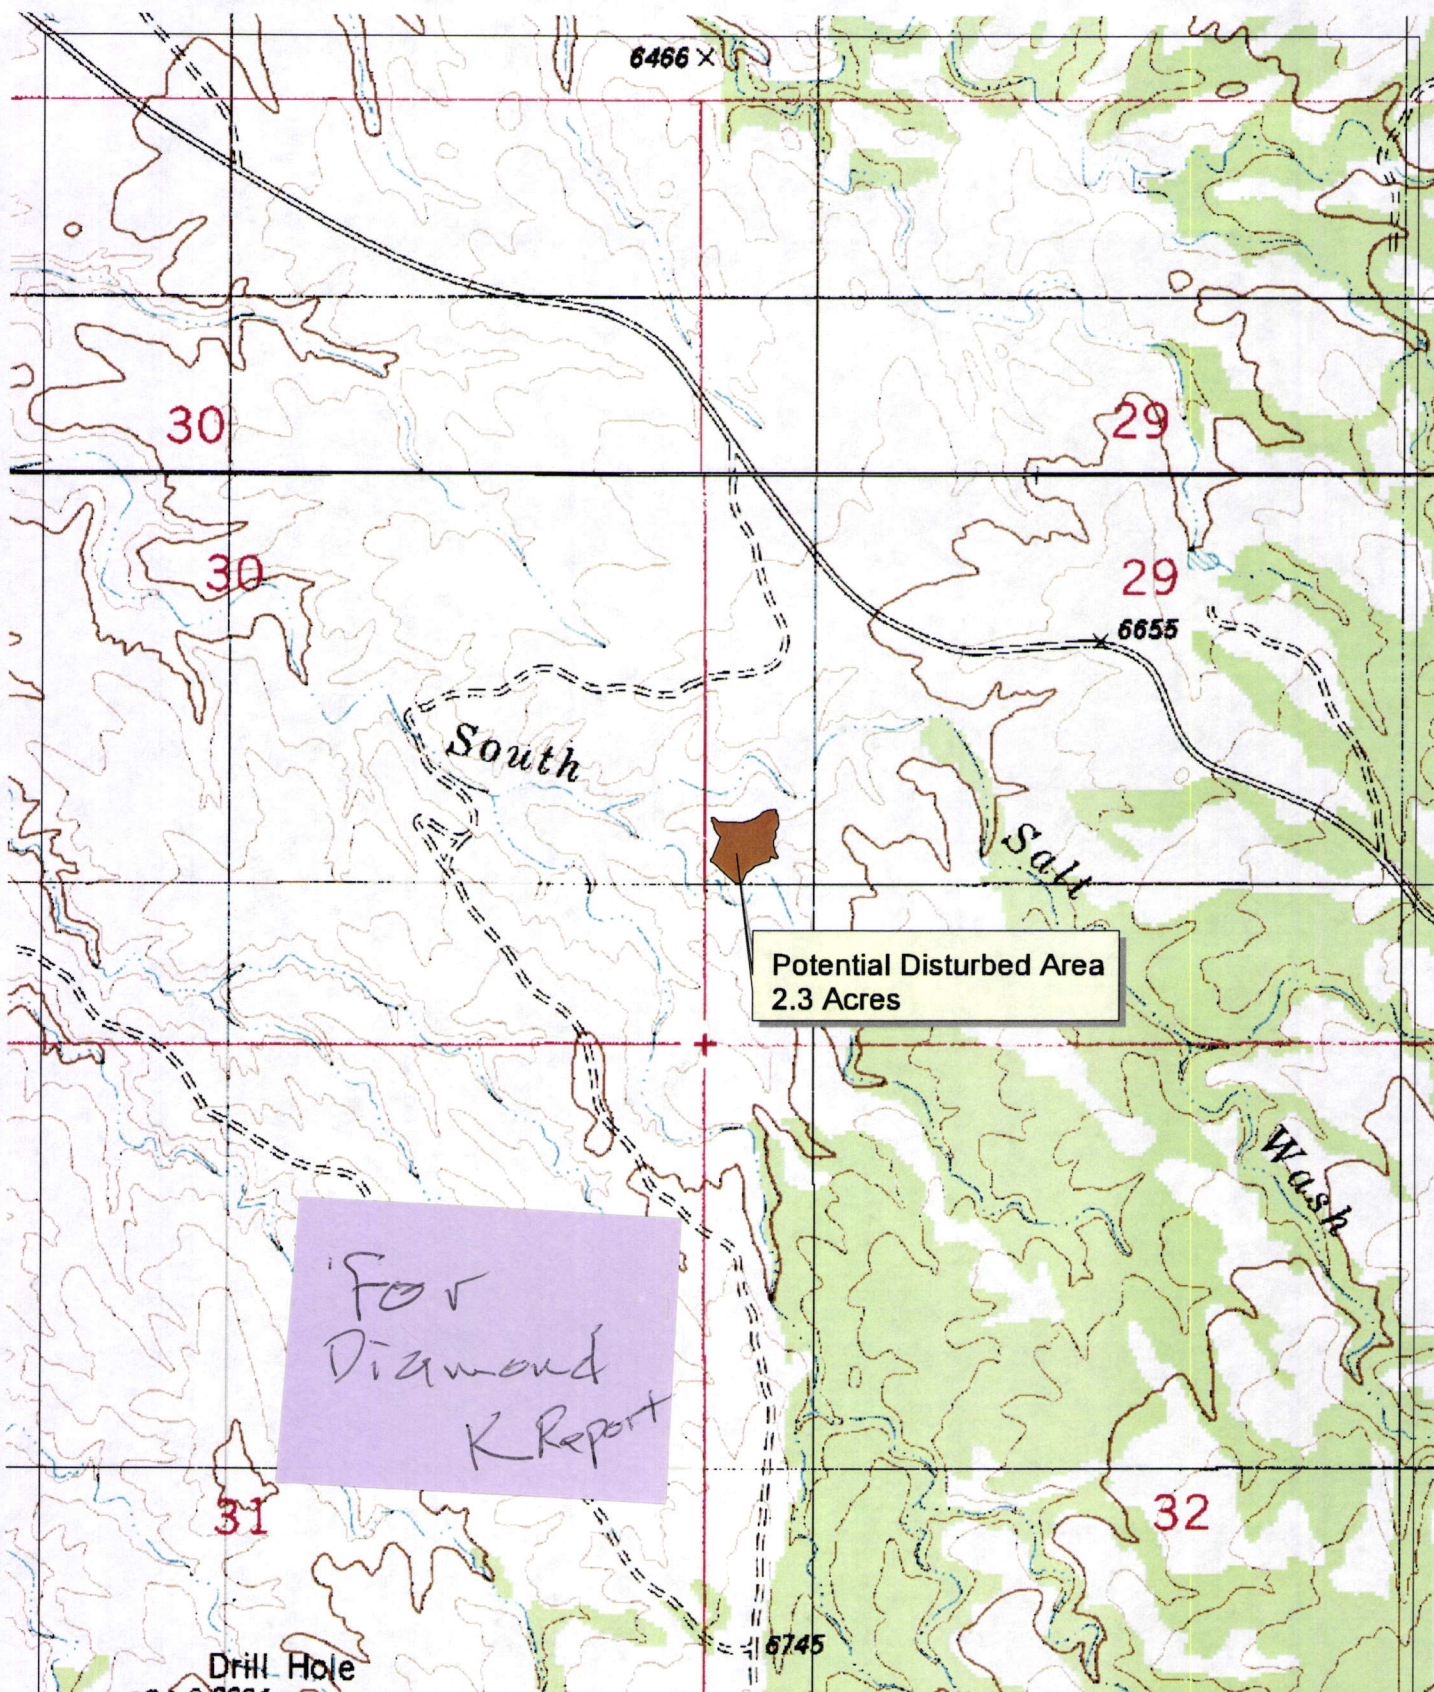
The operator will need to expand the operation soon, and during the previous inspection, Mr. Henry showed me an area they would like to mine. During the current inspection, I took GPS positions around the perimeter of the approximate area we discussed. The area is 2.3 acres. I do not know the precise area the operator would disturb, so this figure should only be used as an estimate. The enclosed map shows the area.
